# **PERFORMANCE AUDIT REPORT OF THE AUDITOR-GENERAL ON THE SUSTAINABILITY OF SPORTS STADIA IN GHANA**

**This report has been prepared in compliance with Article 187(2) of the 1992 Constitution of Ghana and Section 13(e) of the Audit Service Act, 2000 (Act 584)**

**Daniel Yaw Domelevo  
Auditor-General  
Ghana Audit Service  
30 December 2019**

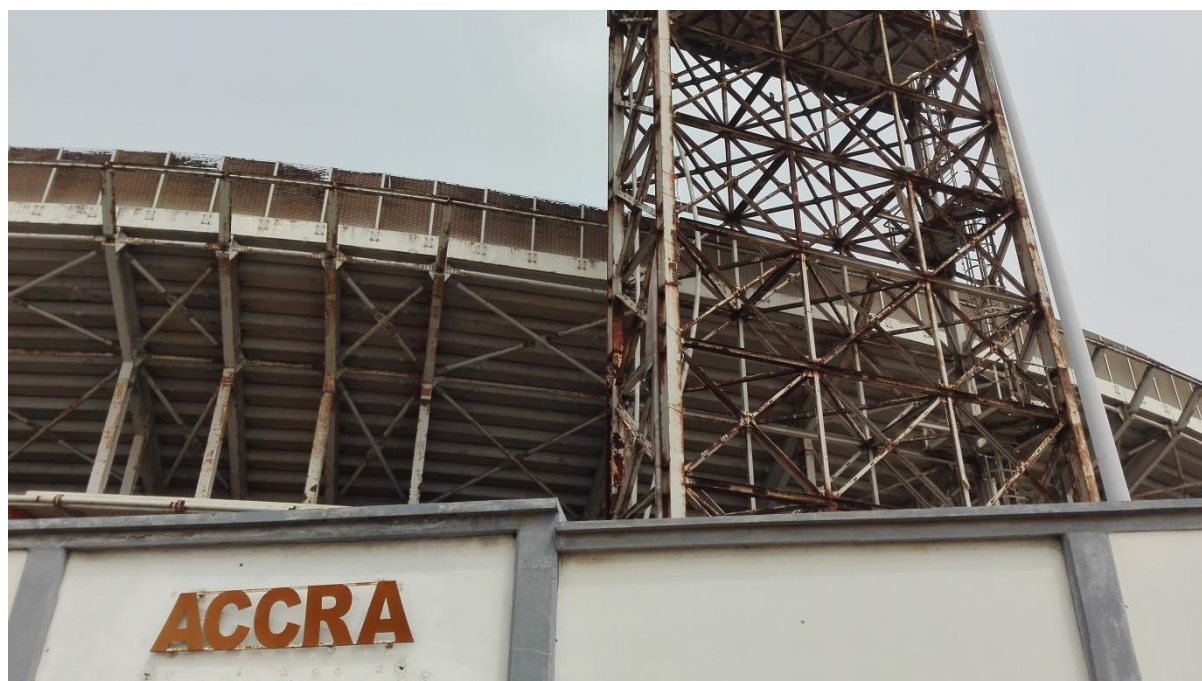
**Picture 1: Rusty part of the score board at the Accra Stadium**

7. In 2014, six years after the tournament, media reports appeared about the fast-deteriorating state of the stadia. For instance, scoreboards had stopped working, steel beams were rusting, the playing fields needed fresh turf, and the facilities needed repainting. Picture 1 shows rusty portions of the score board at the Accra Sports Stadium.

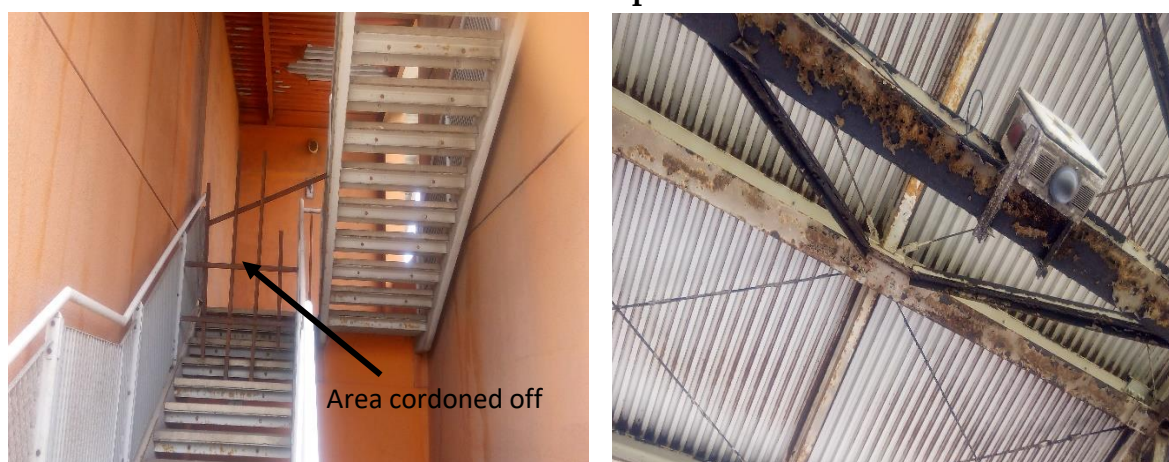
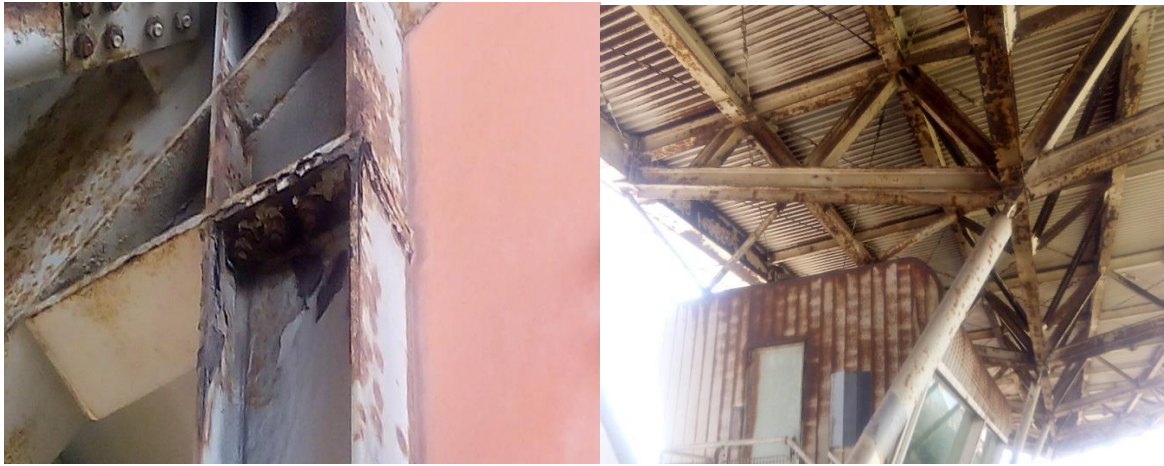
**Picture 2: The state of VIP Stand at Accra Sports Stadium at the time of the audit**

54. We noted that in October 2010, NSA observed some corrosion of the steel members of the VIP roof, the Score Board and areas exposed directly to the sea at the stadium and therefore requested Architectural and Engineering Services Limited (AESL) to carry out an assessment of the entire stadium. AESL's report identified corrosion of steel members around the stadium with the VIP stand, public stands, offices, score board and floodlights being the worst affected areas.

57. Our further review of a correspondence file at the Accra Sports Stadium showed that MoYS and NSA again did not implement the recommendations made by AESL during its assessment in 2012. As a result, AESL was made to carry out a third assessment in July 2015 as the deterioration worsened. The 2015 assessment report described the state of the stadium, especially the steel members as having corroded beyond salvage and therefore indicated that it will cost Government about GH¢12,615,125 to refurbish it. The report recommended the following:

58. In the course of our audit, we observed during a physical inspection of the Stadium in September 2017 that, the VIP stand had been cordoned off based on recommendation by AESL that it could collapse due to the bad state of the steel members. Picture 2 show sections of the corroded steel members around the VIP area at the Accra Sports Stadium.

55. The report recommended degreasing or disc sanding to remove all traces of rust and other loose materials after which, one coat of Inter Zinc 52 Epoxy Primer and two coats Interthane 990 Acrylic Polyurethane paint should be applied on the metal surfaces. We however noted through interviews with management of the Stadium and AESL as well as a review of the maintenance files that the recommendations made by AESL were not implemented.

56. In September 2012, it became necessary to invite AESL to carry out a further assessment as the metal structures of the stadium kept deteriorating. In the 2012 report, AESL recommended a new treatment technique with the use of Rhino Shied or Zinga treatment at a cost of GH¢9,115,675.

- the structure should be closed down to major sporting activities that result in crowding of the stands for serious rehabilitation works.
- complete replacement of some sections as they have been so much affected that they can no longer perform to strength and safety standards. Those sections that are still adequate structurally should be cleaned by Sponge-Jet Blasting
- all steel components should then be recoated with products from companies reputable in handling anti-corrosion works.

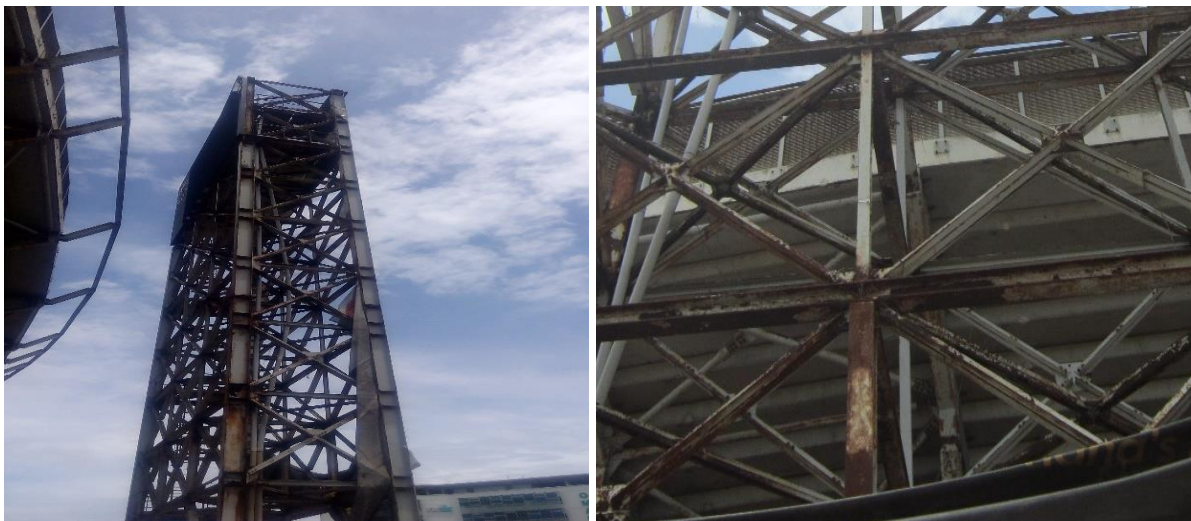
**Picture 3: The state of the scoreboard stands at Accra sports stadium during the audit**

59. We also found that the score board was not functioning and its stand had corroded. Picture 3 depicts the state of the score board during the audit.

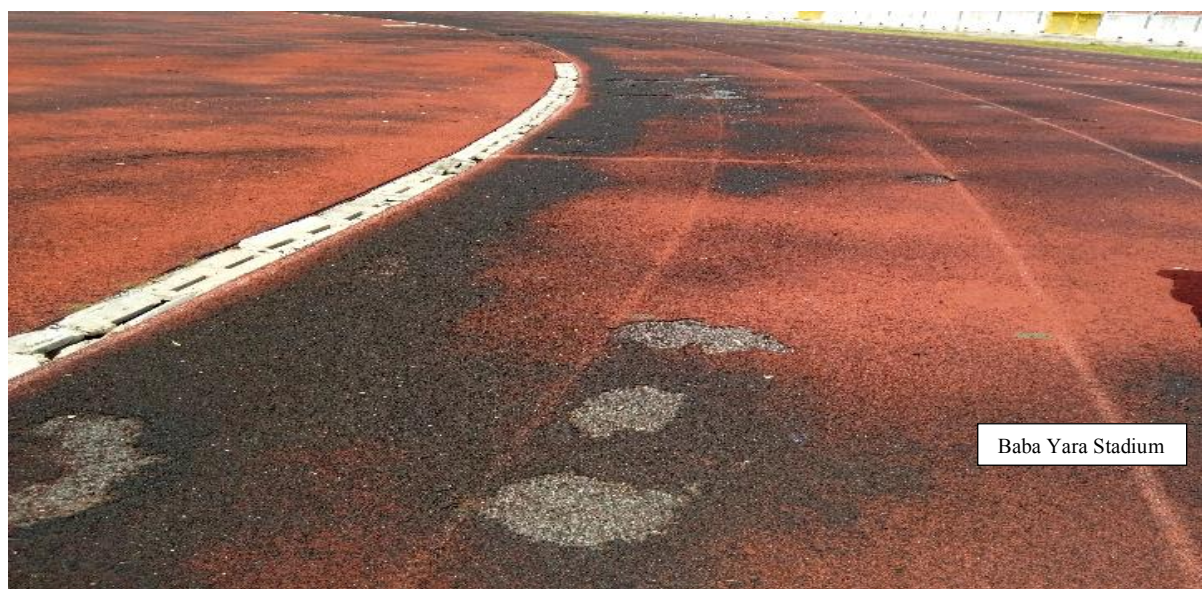
**Picture 4: Tartan tracks at Baba Yara Stadium**

63. We noted during our physical inspection that, water had collected at some portions of the tracks and had made those parts dark red and patchy with portions ripped off as shown in Picture 4. The Estate Officer attributed the problem to the unevenness of the track and its frequent use as most sporting events in the region were hosted at the Baba Yara Sports Stadium.

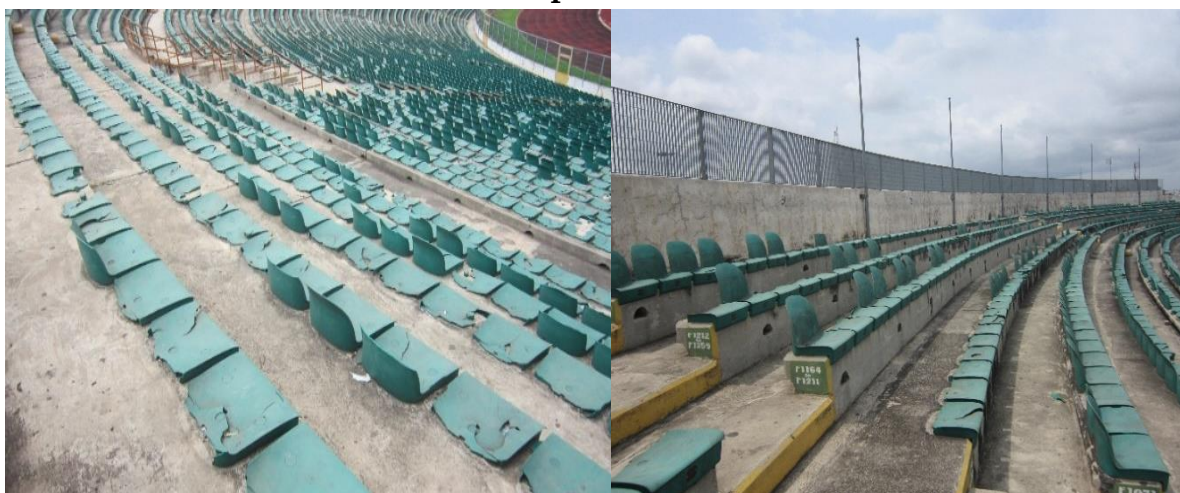
**Picture 5: Broken seats at Baba Yara Sport Stadium**

64. Our inspection showed that, out of the 40,000 seats at the Stadium, about 6,404 were broken and needed replacement. The Estate Officer informed us that 2,829 of the 6,404 seats got broken during inter-colleges competition in the Region and that the schools that took part in the competition were surcharged with the cost to enable management replace them. The Estate officer added that the remaining 3,575 seats got broken either by spectators or due to the harsh weather condition, as

the seats were not under any roof. Picture 5 show sections of the broken seats at the Baba Yara Sports Stadium.

8. To ensure the physical sustainability of the stadia, we recommended that:
- in the immediate to short term, NSA through MoYS should request for the Operations and Maintenance Manuals from the contractors who constructed the stadia and put together a team of experts to evaluate the maintenance needs of the stadia and come up with a sustainable plan for maintenance.
  - NSA should draw up annual plans from the operation and maintenance plan and ensure their implementation.
  - NSA head office should refund the amount of GH¢180,494 used for the 2017 National Sports Festival to the management of Baba Yara Sports Stadium to enable them replace the broken seats.

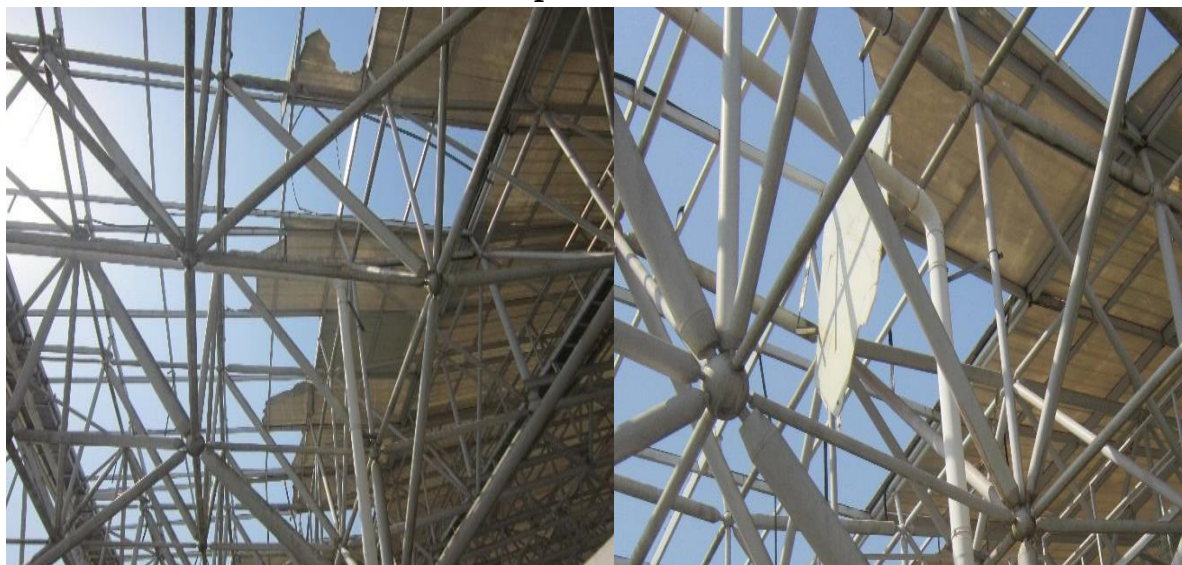
**Picture 6: Portions of the roof at Essipon Stadium**

69. Our physical inspection disclosed that the metal components (including the bolts and nuts) on the roof were rusty and loose. As a result, there were gaping holes in the roof with some of the roofing panels hanging loosely from the trusses, posing danger to staff, spectators and the general public as shown in Picture 6.

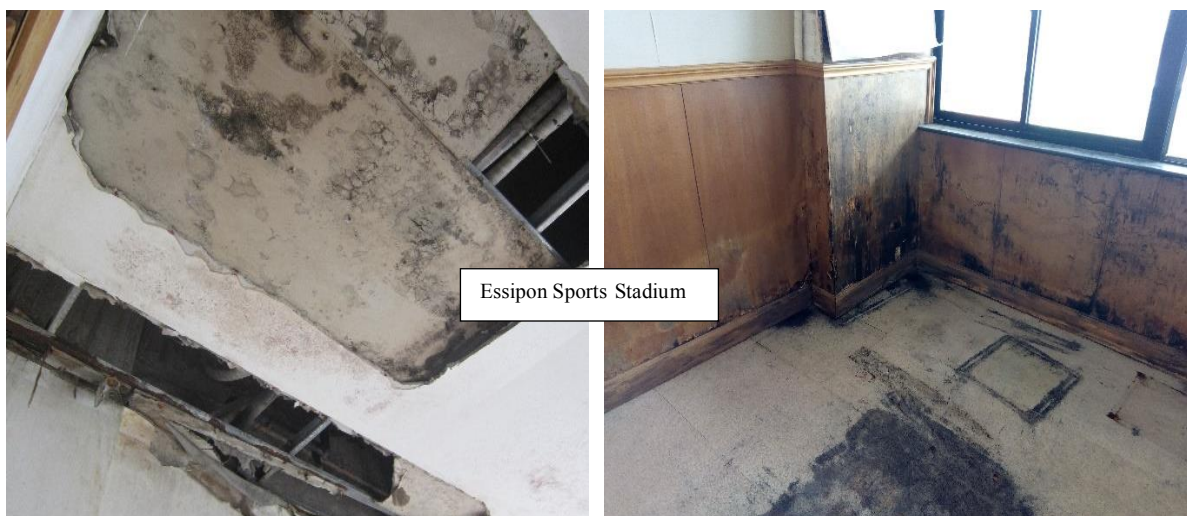
**Picture 7: Portions of deteriorated ceiling and wooden wall at Essipon Sports Stadium**

70. The gaping holes in the roof as shown in Picture 6 resulted in leakages when it rains and this had damaged portions of the ceilings, wooden wall panels and flush doors. Picture 7 below shows portions of the stained and deteriorated areas.

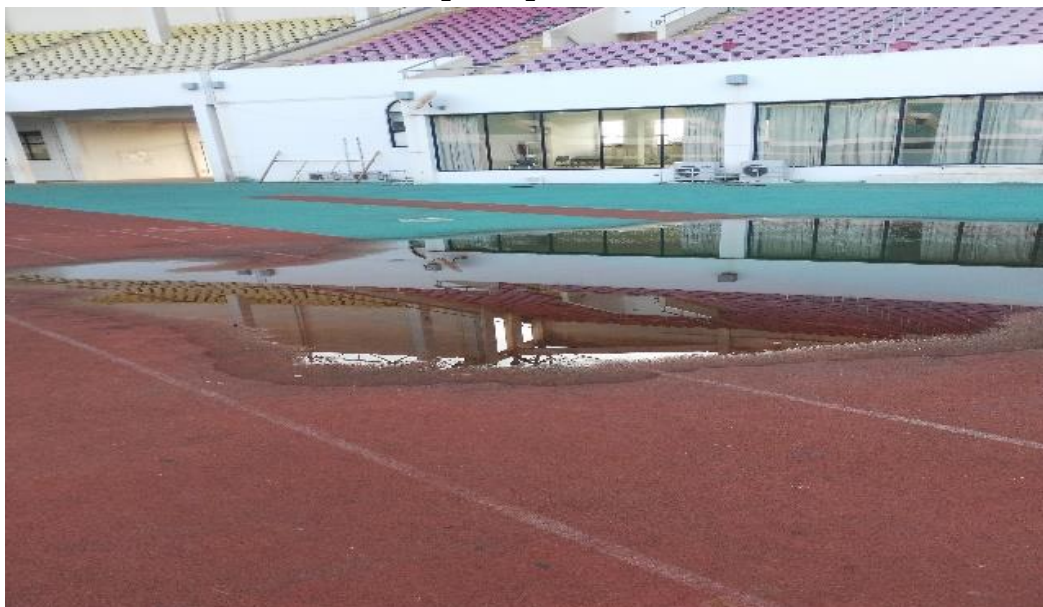
**Picture 8: Tartan tracks at Essipon Sports Stadium**

71. We found during our physical inspection at Essipon Sports Stadium that portions of the tartan tracks were uneven and created stagnant water when it rains. This could result in patchy spots and eventual rip off as noted at the Baba Yara Sports Stadium, leading to increased maintenance cost if steps are not put in place to

remedy the situation. Picture 8 shows a portion of the tartan track at Essipon Stadium.

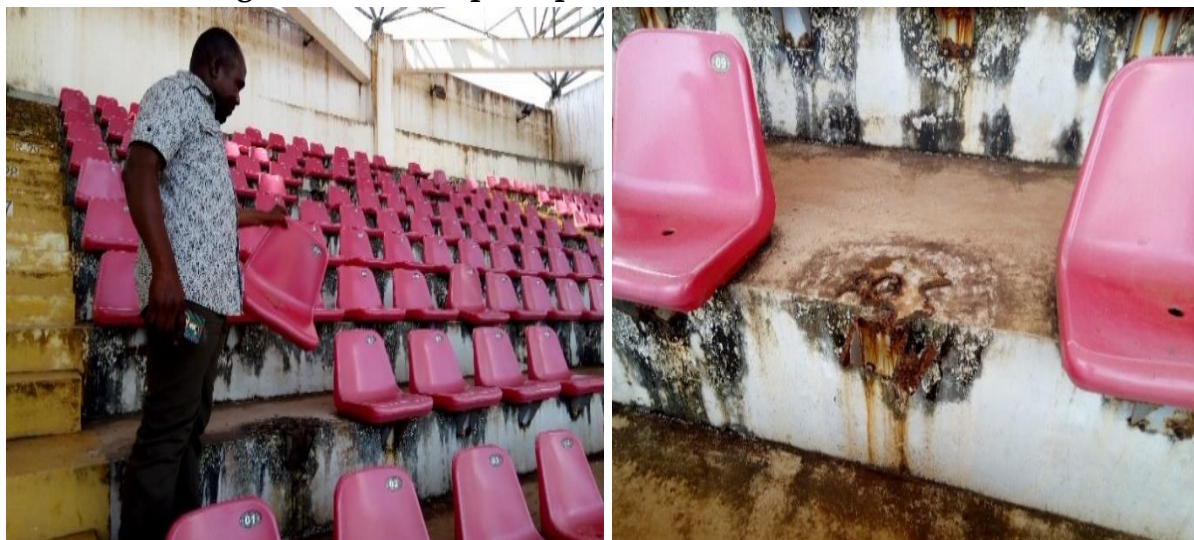
**Picture 9: Damaged seats at Essipon Sports Stadium**

72. Our physical inspection at the Stadium disclosed that 300 seats were damaged and needed replacement. We also noted that the metal base on which the seats on the red wing were anchored had rusted leaving all the seats loose. The Estate Officer explained that seats at the red wing deteriorated faster because it was more exposed to the sea than the other parts of the stadium. He added that even though the remaining 5,080 seats on the red wing were in good condition, their metal base will have to be replaced. The damaged seats have reduced the seating capacity of the stadium. Picture 9 shows a section of the damaged seats at the Stadium.

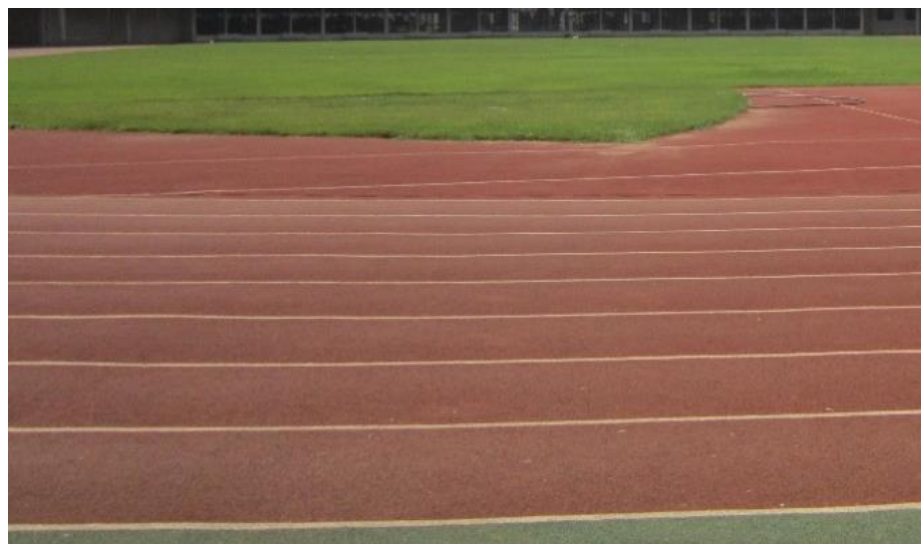
**Picture 10: Tartan tracks at Tamale Sports Stadium**

73. We observed that the tartan tracks at the Tamale Sports Stadium was even and in good condition as shown in Picture 10. The Director of the Stadium explained that due to less pressure on the stadium the tracks still looked intact.

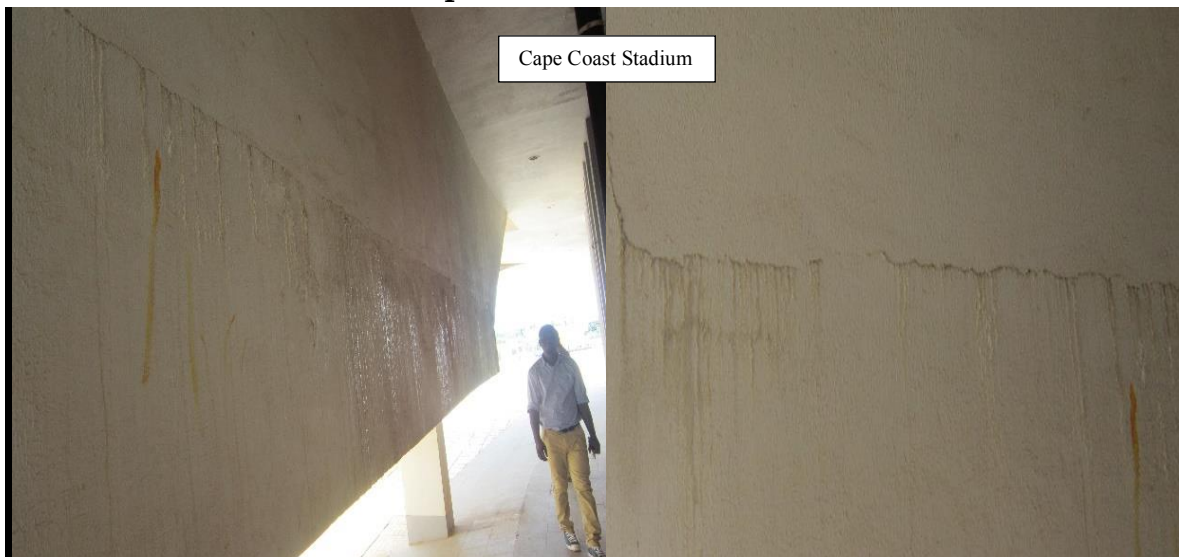
**Picture 11: Stained walls at Cape Coast Stadium**

76. We also observed that portions of the roof over the VIP wing and metal grills used to cover the drains in the washrooms of the changing rooms have started to rust. We further noted that water drips through the concrete slabs around the staircase areas even though water spouts have been introduced to drain the water off the concrete slabs. This has the potential of weakening the reinforced members and rendering the entire area weak to support its intended load. Picture 11 shows the stained walls at Cape Coast stadium barely a year after it was handed over in 2016.

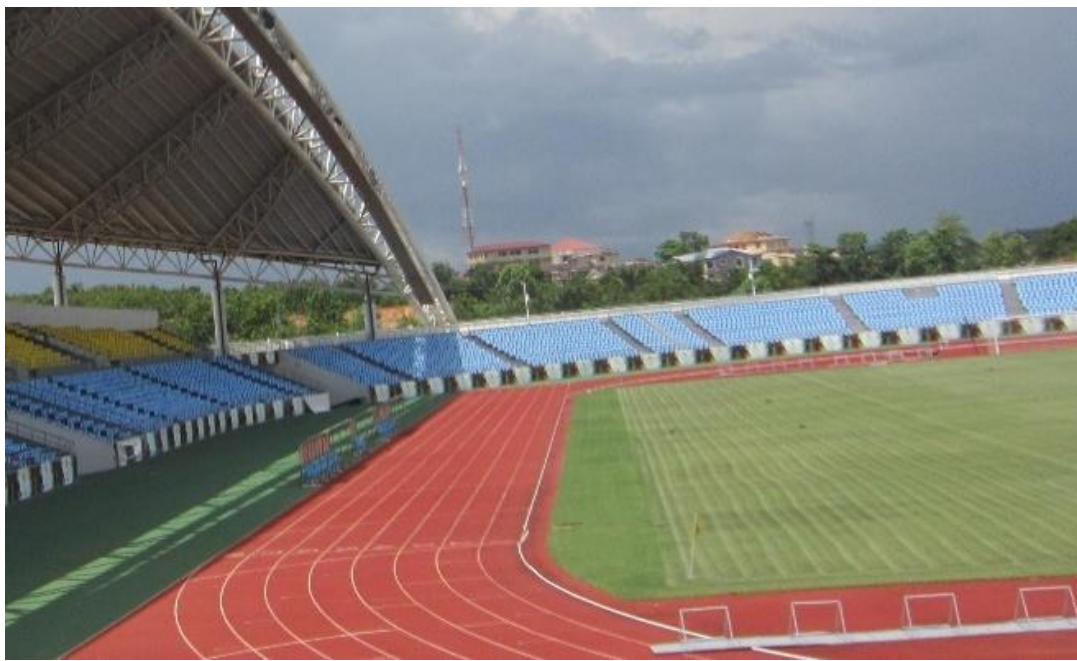
**Picture 12: Portion of tartan tracks at Cape Coast Stadium**

78. We noted that the tartan tracks at the Cape Coast Stadium was even and in good condition as shown in Picture 12. The Director of the Stadium explained that the stadium was fairly new and due to less pressure on it, the tracks still looked intact.
